# Sensitization of Gold Dust in 430 Grade Stainless Steel

S.Mithra<sup>1</sup>, P.G.Venkatakrishnan<sup>2</sup>, D.Noorullah<sup>3</sup>, V.Karthik<sup>4</sup>

<sup>1</sup>ME research student, welding technology, Department of Metallurgical Engineering, Government College of Engineering, Salem, India

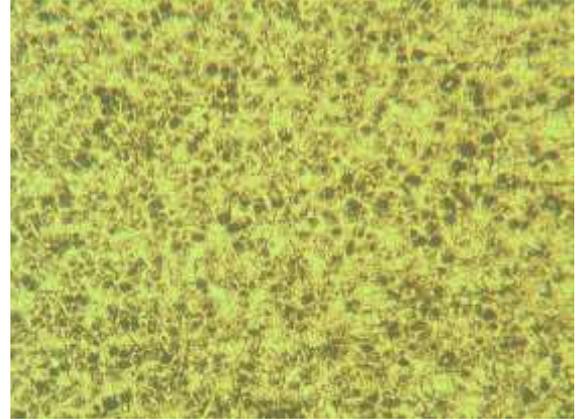
Fig.3.1.1: Partially recrystallized structure with carbide precipitates at grain boundaries.

From metallurgical micrograph (Fig 3.1.1 and Fig 3.1.2), in Gold dust sample, the areas near the grain boundaries appear black indicating that they are empty, the grain boundaries are distorted towards the surface. In Scanning Electron Microscope and Energy Dispersive Spectroscopy Gold dust samples show a significant decrease in % Cr and increase in %C clearly indicating that the area affected by defect suffers Chromium depletion and the related Chromium Carbide precipitation. The increase in % O<sub>2</sub> is also due to the above fact that there is no sufficient Cr for passivation and hence an oxide formation at the surface.

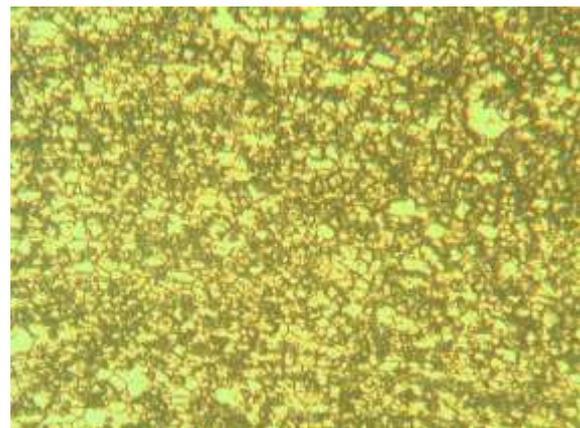
Fig.3.1.2: Fine recrystallized ferritic grains of size 8 throughout with profuse carbide precipitation.

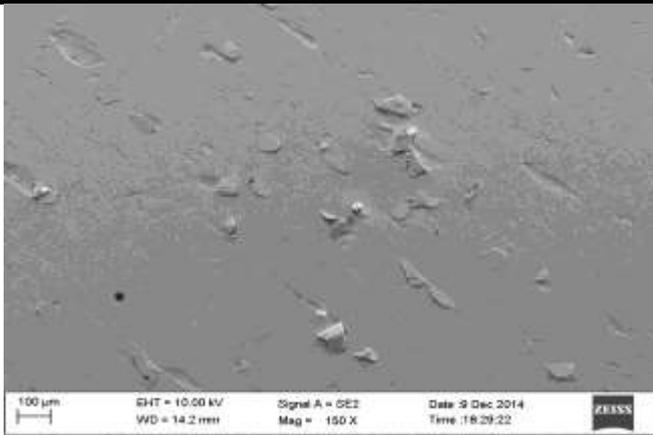
SEM has a large depth of field, enabling characterization of fractured surfaces. The combination of high magnification, larger depth of focus, greater resolution and ease of specimen observation. SEM is the one of the most used instruments for material characterization. The SEM images (Fig 3.2.1 and Fig 3.2.2) reveal that gold dust formed comes from material not from the external atmospheres during their manufacturing process. Thus the material had undergone chemical reaction during the transformation.

Fig.3.2.1: Scanning electron photomicrograph of cold rolled surface of 430 grade stainless steel at 150X

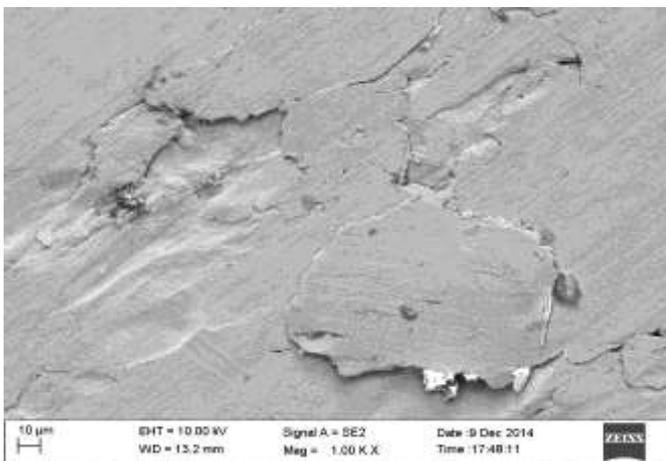
Fig.3.2.2: Scanning electron photomicrograph of cold rolled surface of 430 grade stainless steel at 1000X

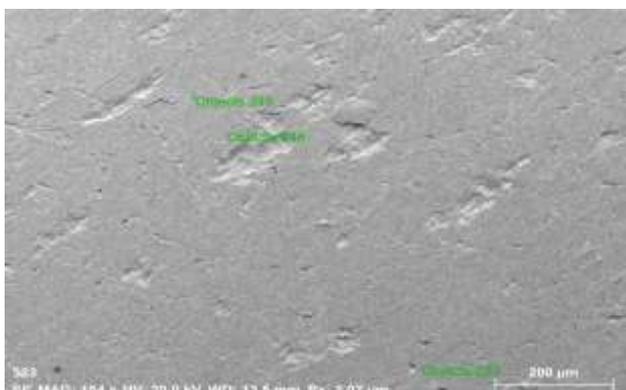
Fig 3.3.1: Micrograph from energy dispersive spectroscopy. Analysis is done at two points: one at the defect area and another on the surface near the defect

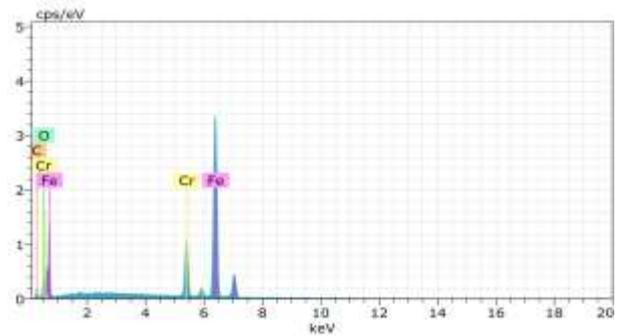
Fig.3.3.2: Graph obtained at the area of the defect at point 248 in energy dispersive spectrometer micrograph

The Spectrum obtained from objects 248 shows  
 El AN Series un. C norm. C Atom. C Error (1 Sigma)

[wt.%]	[wt.%]	[at.%]	[wt.%]
Fe 26 K-series	78.93	78.87	61.48	
2.13				
Cr 24 K-series	12.87	12.86	10.77	
0.38				
C 6 K-series	5.83	5.82	21.11	
1.19				
O 8 K-series	2.44	2.44	6.64	
0.49				
Total:		100.08	100.00	100.00

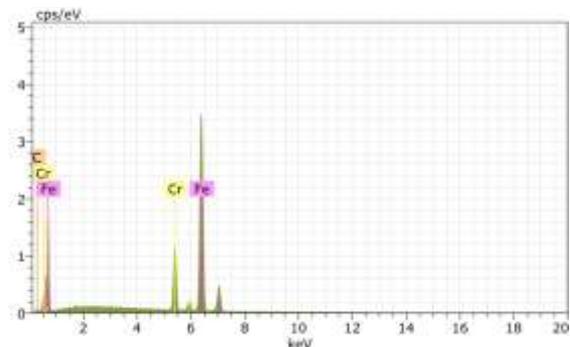
Fig 3.3.3: Graph obtained at the area near the defect at point 249 in energy dispersive spectrometer micrograph

The Spectrum obtained from objects 249 shows  
 El AN Series un. C norm. C Atom. C Error (1 Sigma)

[wt.%]	[wt.%]	[at.%]	[wt.%]
Fe 26 K-series	80.25	82.68	73.59	
2.17				
Cr 24 K-series	13.81	14.22	13.60	
0.41				
C 6 K-series	3.01	3.10	12.81	
0.76				
Total:		97.07	100.00	100.00
